CARING FOR OUTDOOR SCULPTURE IN LUGANO, SWITZERLAND: PREVENTIVE CONSERVATION AND LONG TERM MAINTENANCE

Outdoor sculpture, preventive conservation, inspection, care and maintenance, preventive management, risk assessment.

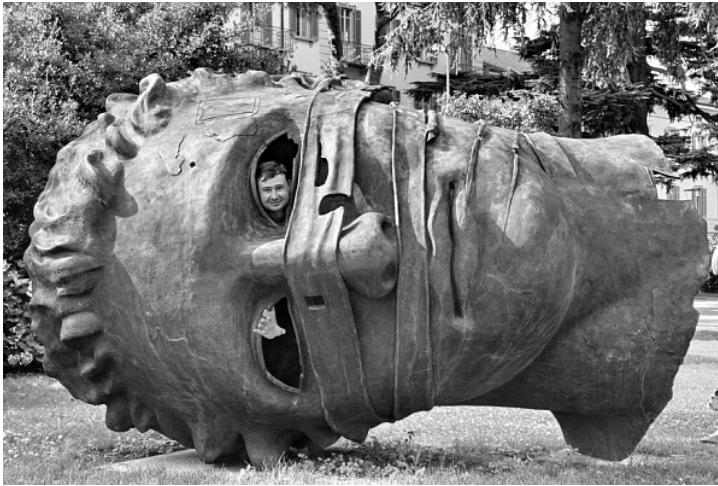
Fig. 1. *Eros bendato* by Igor Mitoraj, 1999. This giant-size bronze head is hollow and the public is free to climb inside. Although this open access might be part of the artist's intent, it increases the risk of physical damage to the sculpture due to wear or vandalism. (Photo. May 2008, SUPSI-DACD).

sculptures were added to the collection (such as *Eros Bendato* by Igor Mitoraj, fig. 1). These exhibitions continue up to the present day and although there is no acquisition policy as such, the collection will continue to grow in the coming years as works are added on a one to one basis.

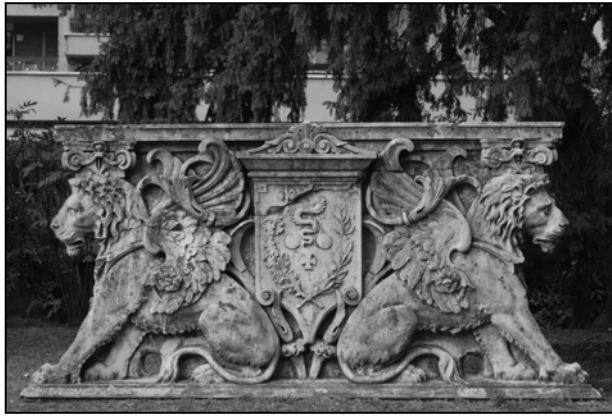
Fig. 2. *Stemma della famiglia von Derweis*, by Vincenzo Ragusa, 1875. This decorative element originally formed part of the pediment adorning the entrance façade of Trevano Castle above Lugano. Following the demolition of the castle in 1961, this and other elements were recuperated by the cantonal authorities and displayed in the grounds of Lugano's high school. (Photo. May 2008, SUPSI-DACD).

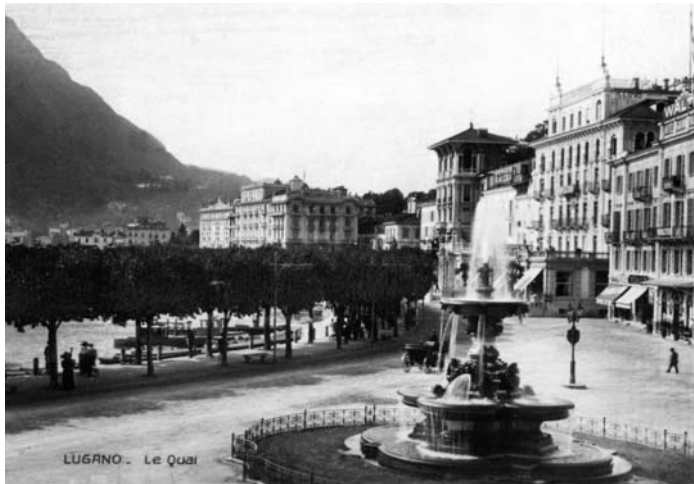
Fig. 3. *Fontana Antonio Bossi* by Otto Maraini and Luigi Vassalli, 1895. In this view of the fountain shortly after its construction, we can see a low perimeter fence providing some protection. As with other sculptures in Lugano, these barriers no longer exist. (Photo. end 19th century, postcard).

Vandalism: easily accessible and with no surveillance, outdoor sculptures are often subjected to different types of vandalism: this can be involuntary, by children climbing on the sculptures, or voluntary by single or repeated acts of depredation. This risk has probably been exacerbated by systematic removal of enclosures and barriers which in the past formed relatively effective deterrents and were often part of the artworks original ground plan (Fig. 3, note 1).

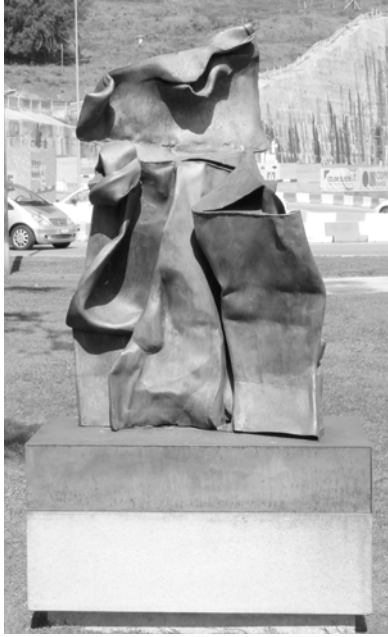
Fig. 4. *Nucleo*, by Paolo Bellini, 1997-98. This iron sculpture is a good example of different parts of the same sculpture requiring different conservation treatments. On close examination, it can be seen that the sculptured element was originally entirely polychrome, while the plinth was not. (Photo. SUPSI-DACD, April 2010)

Diversity of materials: as has already been mentioned, outdoor sculpture can be made from many diverse materials and these will deteriorate in different ways and at different rates; thus no general maintenance plan can be applied to all the sculptures. It is necessary to identify the materials and techniques present and determine the conservation needs of each object, or in the case of a composite sculpture, of each part of the object. Plinths, for example, may have different conservation needs than the sculpture they support (Fig. 4).

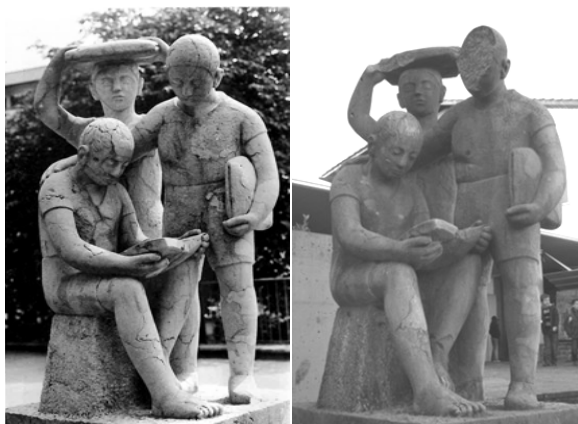
Figs. 5 & 6. *Tre Ragazzi* by Bruno Morenzoni, 1946. On the left, this stone sculpture shortly after its installation. On the right, present condition, with loss of large portions of the face and book. This damage is not due to vandalism but to sedimentary structures passing through the stone (typical for local Saltrio limestone). In order to reduce the risk of further loss, this sculpture may have to be protected by a cover or moved to a sheltered position. (Photo. SUPSI-DACD, archives)

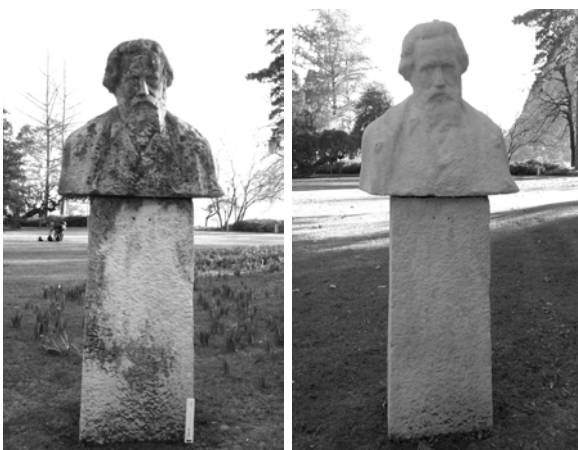
Figs. 7 & 8. *Bust of Vincenzo Vela* by Apollonio Pessina, 1930-50. This stone sculpture, depicting the famous Tessinois sculptor, has suffered from inappropriate cleaning in the past with consequent damage to the stone (two views of the same sculpture before and after cleaning). Better coordination between competent departments can reduce the risk of this type of accident. (Photo. SUPSI-DACD, archives)

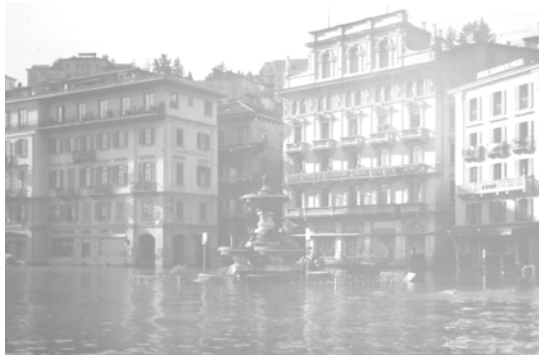
Fig. 9. *Fontana Antonio Bossi* by Otto Maraini and Luigi Vassalli, 1895. View of the fountain during the floods of 1951. This sculpture along the lakefront found itself under 1m of water. Despite this, due to better management of the lake's water levels, the risk of future flooding on this scale is minor (Photo. 1950's, post-card).

Risk management : a global view of the condition of the collection, with a clear identification and evaluation of the risk of future damage, is often lacking; visible damage on a sculpture may lead authorities to precipitate costly intervention when in fact the risk of future deterioration is low and resources would be better concentrated on works judged at higher risk. Similarly, unnecessary steps may be taken to avoid children climbing on a sculpture when in fact the materials have low “vulnerability” to this type of risk. Natural disasters, which may have been high risks in the past, present probably very low risks today (fig. 9)

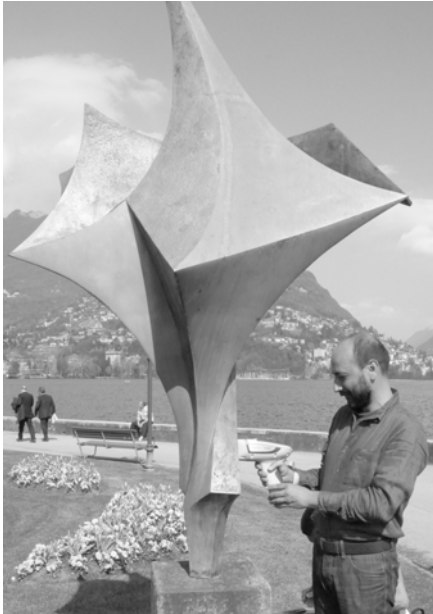
Fig. 11. Portable XRF being used to identify elements present in metal sculptures, in this case *Composizione* by Bruno Morenzoni, 1983. This sculpture was described as aluminium in the literature, but was, surprisingly, found to be an alloy of copper, iron, lead, manganese and zinc. Through these non-destructive semi-quantitative measurements of alloy composition, a better understanding of degradation phenomena is made possible and in turn a more accurate identification and evaluation of future risks. (Photo. April 2010, SUPSI-DACD).

Improving knowledge of the collection: a precise and thorough identification of materials and techniques permits comparison of degradation phenomena and can allow tailor-made conservation treatments. The use of a portable XRF (X-ray fluorescence) device proved to be particularly useful in order to analyse alloy composition of the metal sculptures, as well as the composition of some paint layers on polychrome pieces. Modern alloys can be difficult to identify visually and a more in-depth analysis is necessary (fig. 11). Likewise, past conservation treatments went often un-documented, yet knowledge of such treatments can be essential to
